Manhole Inspection Summary

Manhole # S35G__061MH

Insp Date: **10/31/08 2:32 PM**

Location Address: **side 101 e baltimore st**

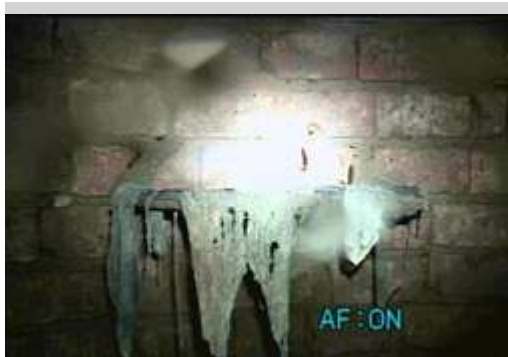
Defect 5

☒ **Evidence Of Surcharge** Depth: **5.5** (ft.) ☐ Active Surcharge Present

surcharge evd

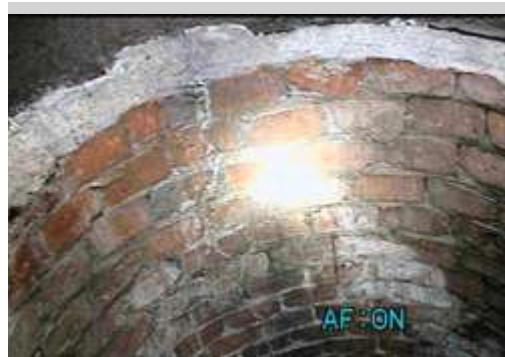
Defect 4

Condition: ☐ Sound ☒ **Cracked** ☐ Root Intrusion ☐ Loose Brick ☐ Deteriorated

cracked corbel

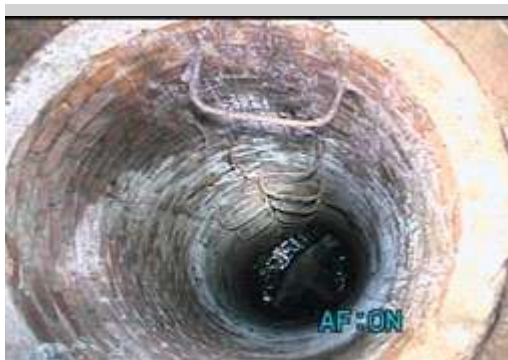
Defect 3

Count: **15** Missing: **3** ☒ **Corroded**

corr steps

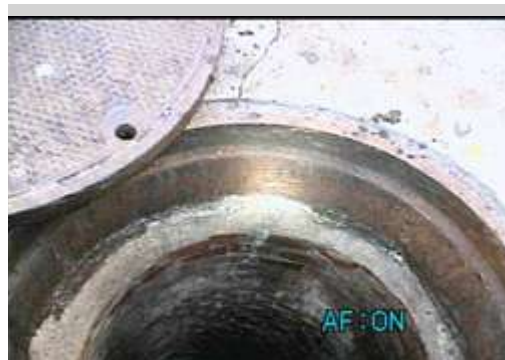
Defect 1

Offset: **3** (in.)

offset
